Parkview Gardens Walk/Bike Audit: Results Report

May 6, 2011

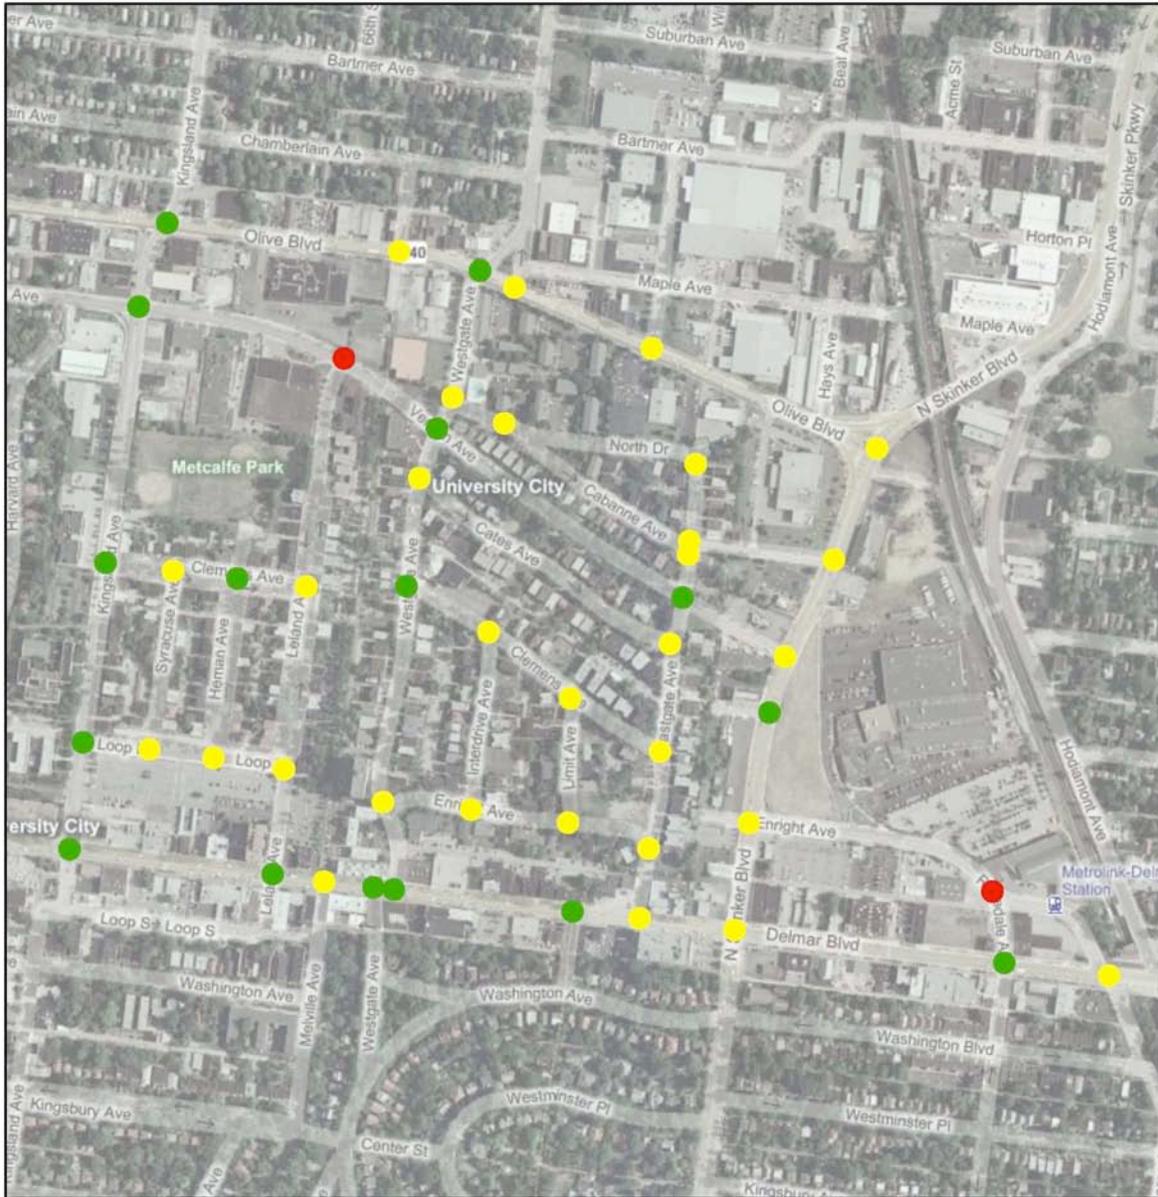
Image 3. A graphical representation of the walk audit scores for all Parkview Gardens intersections.

Intersections along Delmar scored the highest on the walkability checklists. The intersections with stoplights all had walk signals or were fairly walkable, but countdown timers would be a welcome addition at many intersections. Many peripheral intersections on less walkable streets were surprisingly well suited to walking, even though the block following such intersections were typically difficult or unsafe to walk. Interior intersections were less pedestrian-friendly, with few crosswalks and inadequate curbramps, lighting, and pedestrian signage.

Walk Audit Preliminary Results Intersection Data

- Poor (0-4 points)
- Fair (5-11 points)
- Excellent (12+ points)

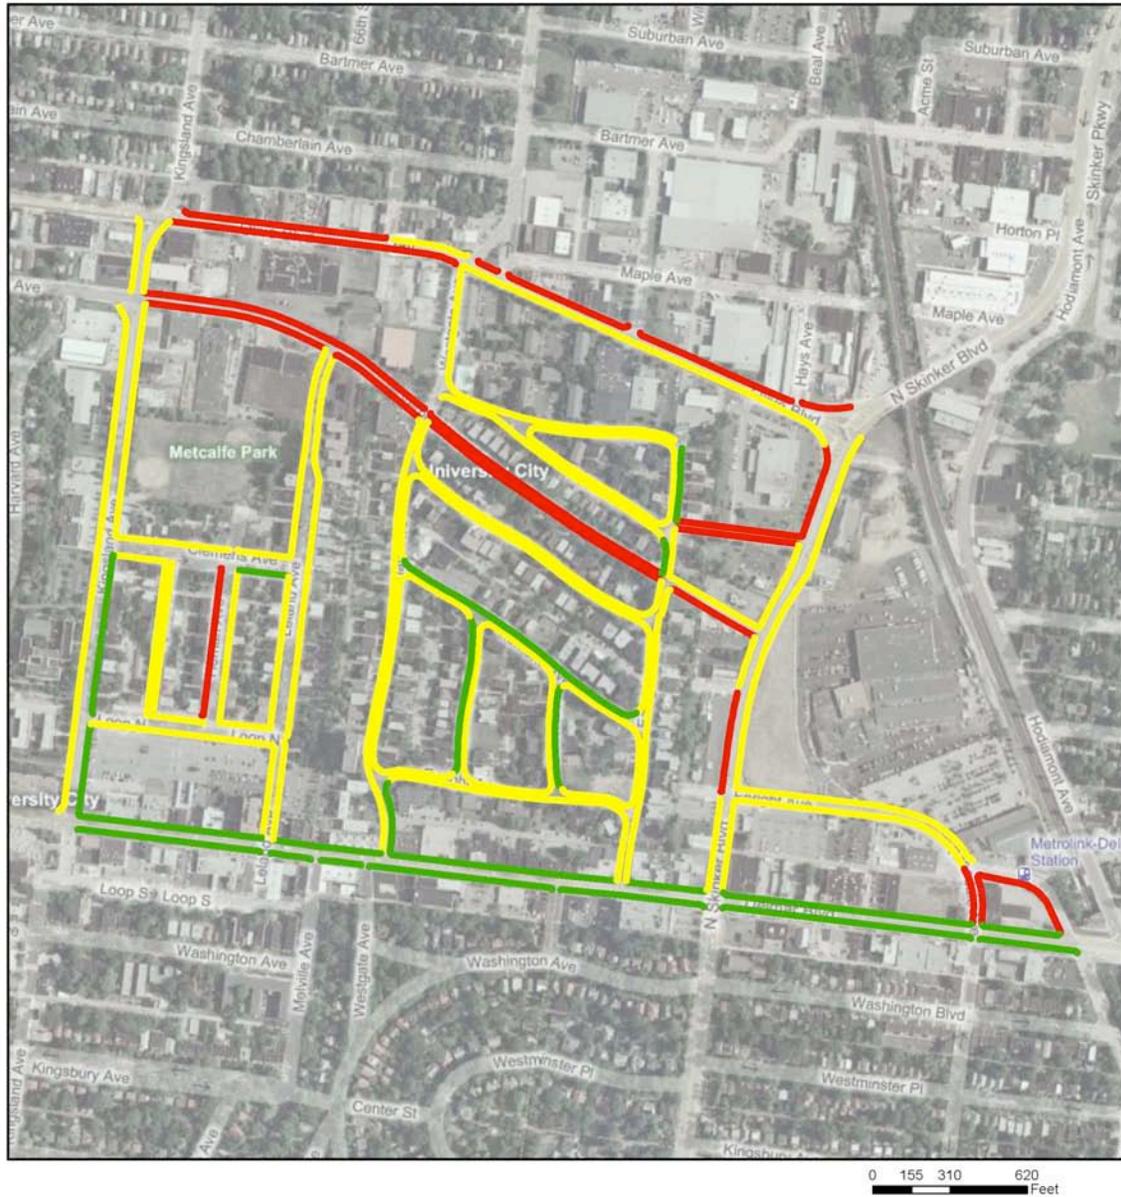
Image 4. A visual representation of the walk audit scores for all Parkview Gardens mid-blocks.

The midblock sections were less walkable around the periphery of the neighborhood, where automobile traffic is higher (Skinker, Olive, Vernon). The exceptions to this rule are Kingsland and Delmar, which were both scored as more walkable streets. There is a need for increasing the tree lawn coverage and sidewalk widths, and some tree lawns are currently in the wrong location (in between the building and the sidewalk, as opposed to in between the street and the sidewalk). There was not much trash or graffiti, and teams felt safe, but transit stops were grossly inadequate at providing safe, comfortable places to wait for transit.

Walk Audit Preliminary Results Midblock Data

- Poor (0-10 points)
- Fair (11-18 points)
- Excellent (19+ points)

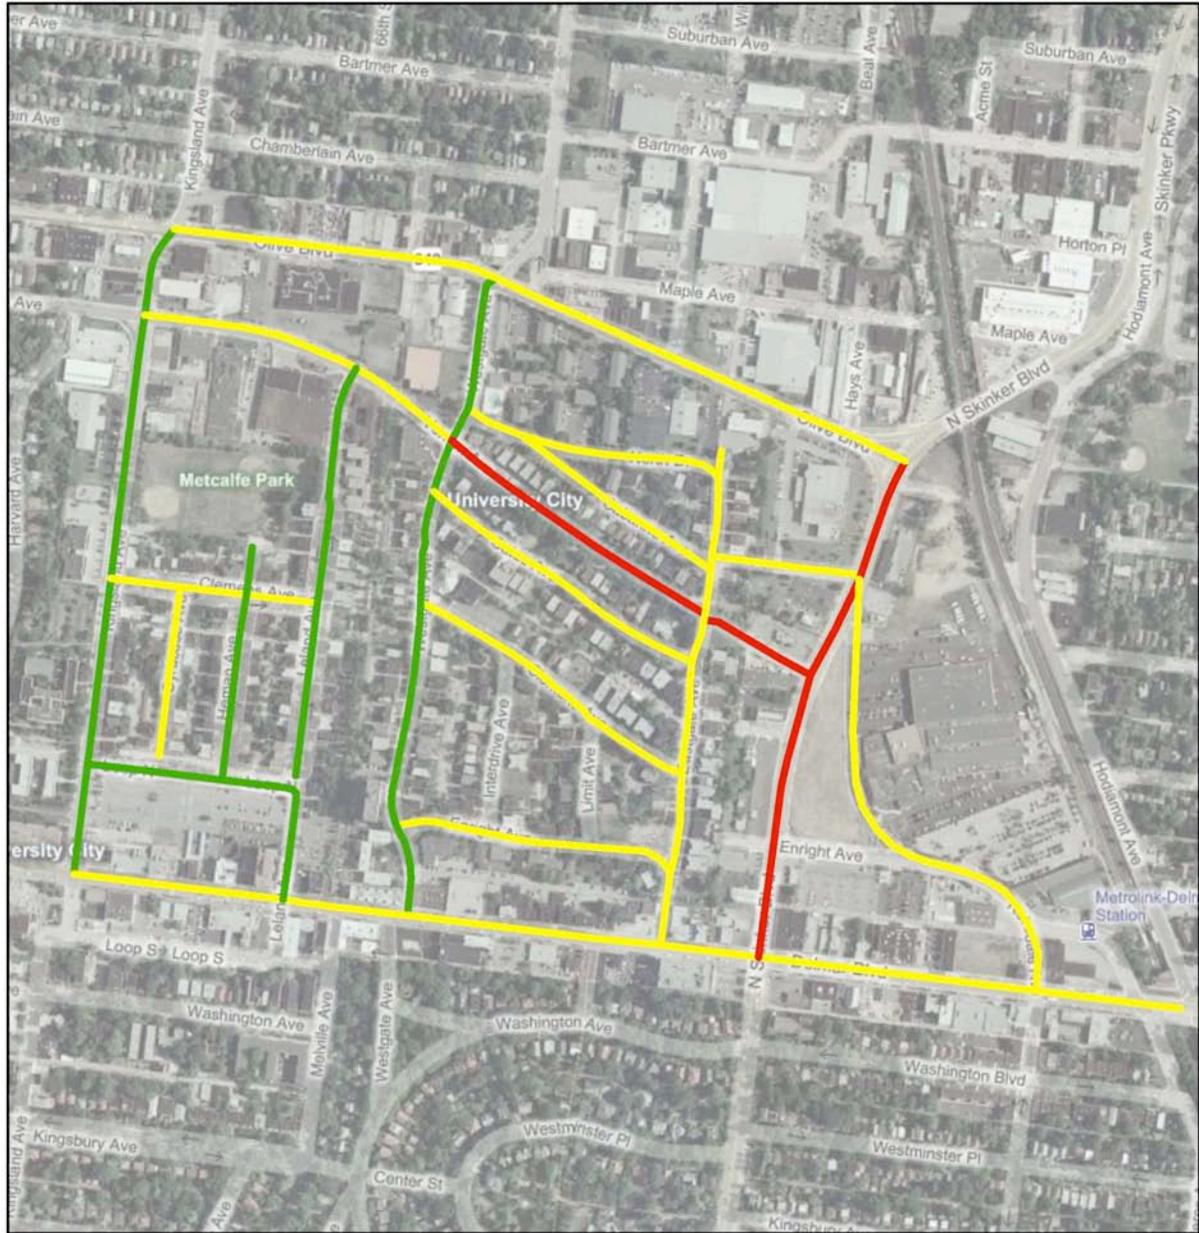
Image 5. A graphical representation of the walk audit scores for all Parkview Gardens intersections.

When asked how to improve cycling conditions, the most frequent improvement idea shared was to add a bicycle lane to existing streets. Bike racks, street sweeping, improved lighting, and decreased vehicle speeds were also mentioned. Although there are bicycle racks at the MetroLink stop, they were not visible enough since the bike team could not see them.

Walk Audit Preliminary Results Cycling Data

- Poor (0-5 points)
- Fair (6-11 points)
- Excellent (12+ points)
